**MDEQ/CDM Field Report**  
**Allied Paper, Inc./Portage Creek/Kalamazoo River Superfund Site**  
**Plainwell Time Critical Removal Action**  
**Date: Thursday October 25, 2012**

**Plainwell Time Critical Removal Action**

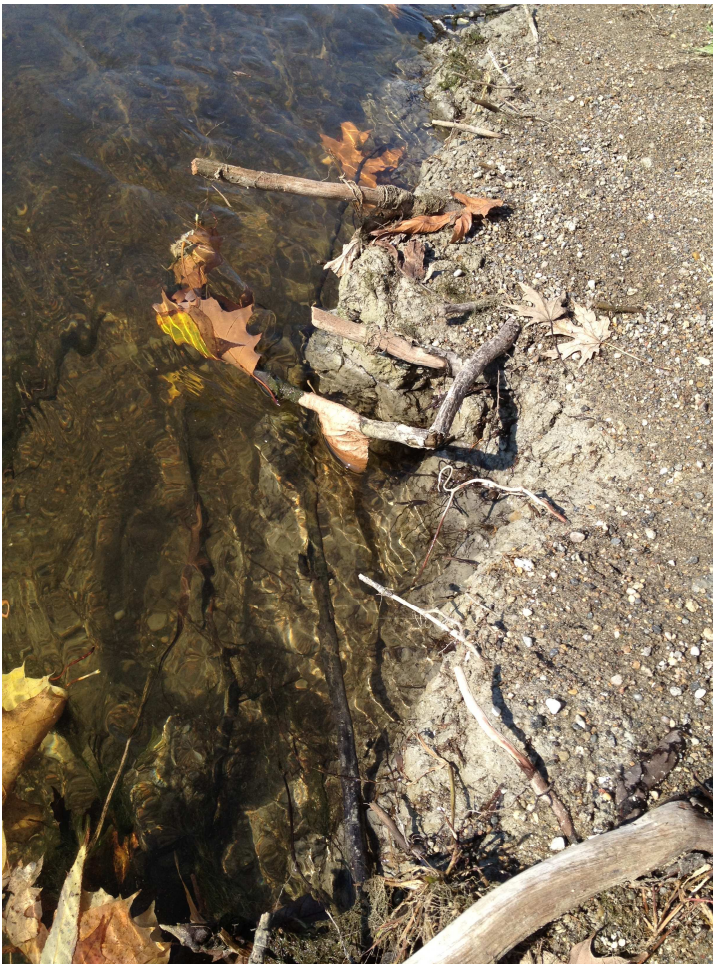
Contaminated residuals are actively being eroded in this area as depicted below.

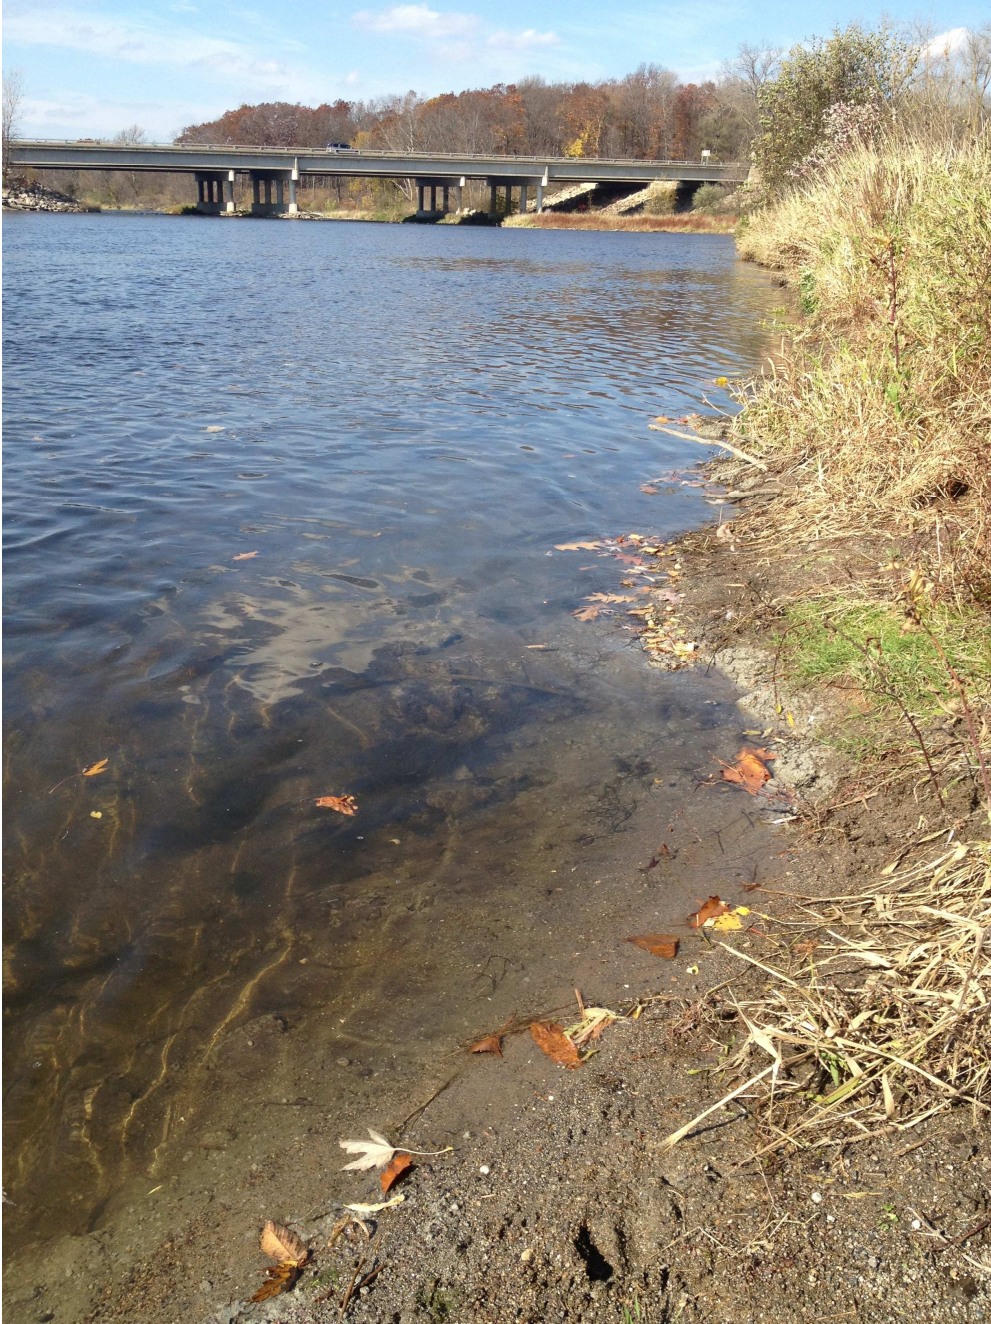
The area of observed bank erosion is upstream of the U.S. 131 bridge, with the relative location depicted below.

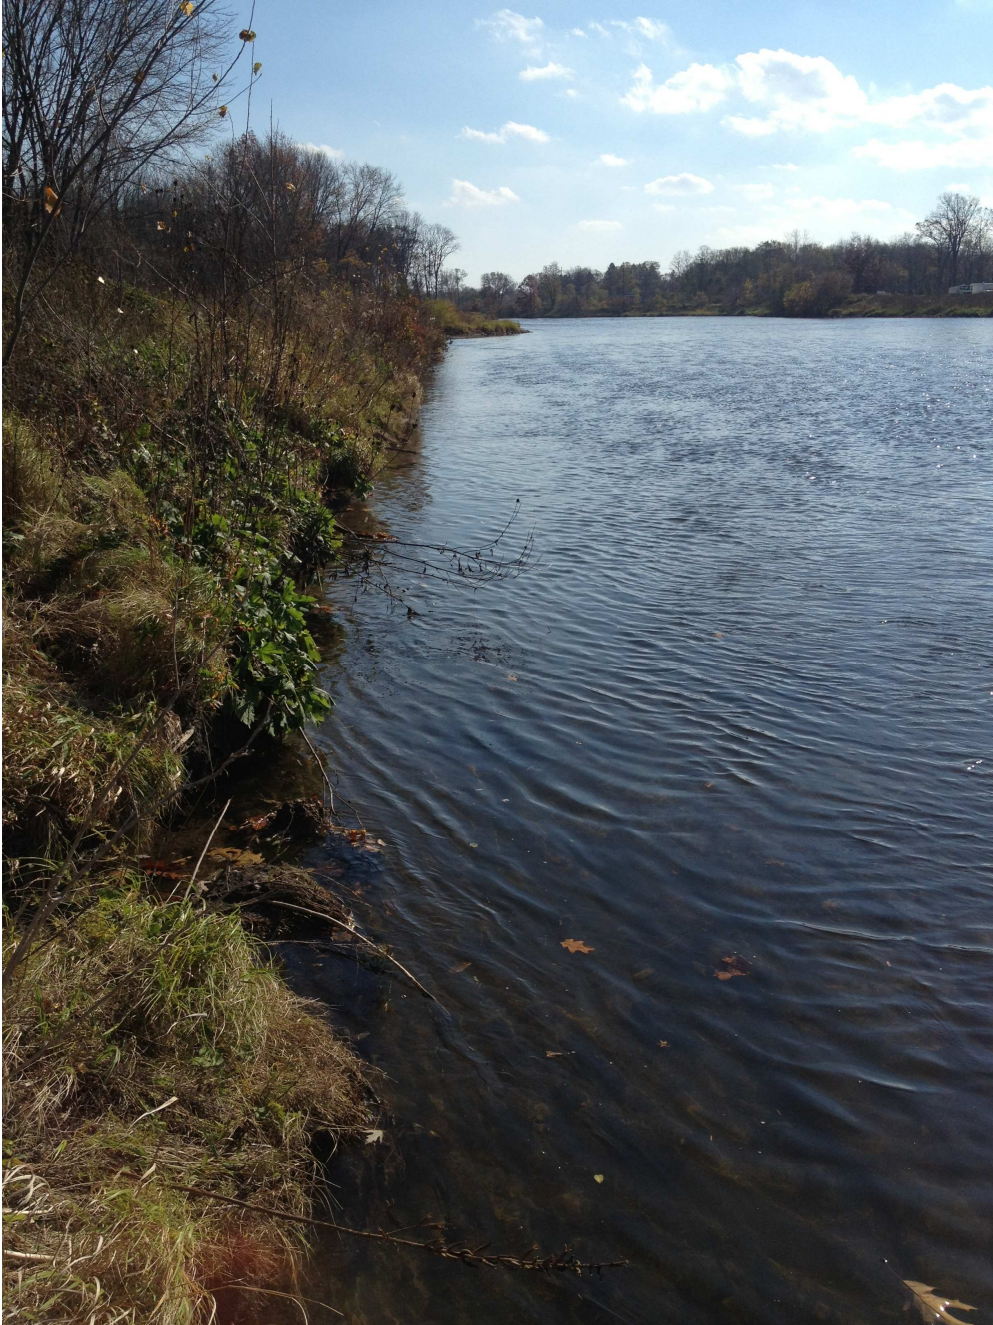
The relative length of the affected bank appears to extend up stream, to the end of the adjacent bank that was armored with river run rock, which can be seen toward the top of the image below.

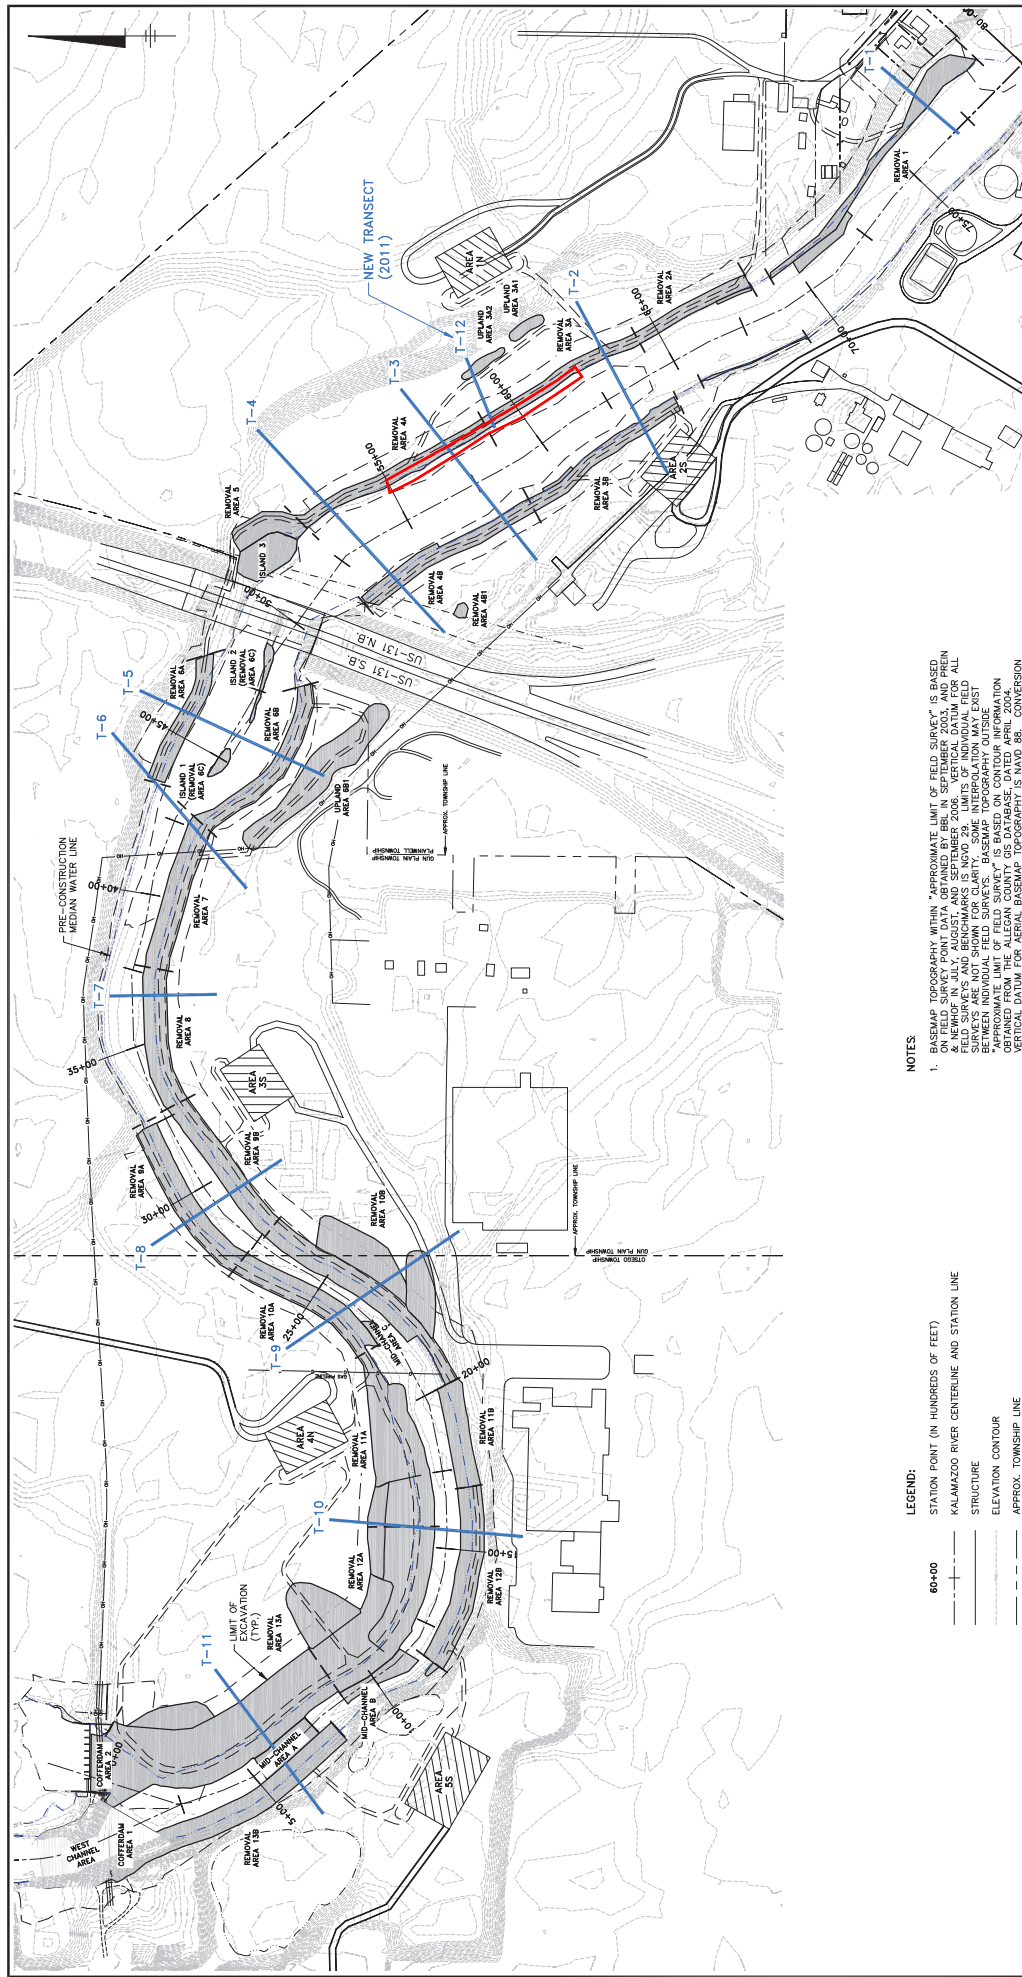
FIGURE 3

The erosion appears to be associated with areas of exaction along the north bank upstream of U.S. 131. In these areas, removal activities resulted in excavation to an elevation below the surface water elevation. As such, excavated areas became inundated during normal flows. At the time of excavation, the shallow shelf that remained contained only a few inches of water. The majority of water flow, was held away from the bank, by the shallow shelf. (at Plainwell Dam #2, excavated areas were backfilled to mitigate the inundation of the excavated areas) At the time, it was envisioned that the shallow shelf may vegetate and stabilize. Use of choir logs on the shelf, to help divert flow, induce deposition, and encourage plant growth, was discussed but it was decided that such measures would not be implemented. It is apparent that the material that once made up the shallow shelf has eroded, water depths have increased, and higher energy flow is now present directly along the bank. Active erosion of the unexcavated, contaminated floodplain material is now evident. At the time of the site visit, specific measurements of the eroding bank were not recorded. Follow up evaluation will be necessary to define the area, and determine if other such areas of erosion exist. The general area of erosion is identified by the red polygon in the attached Figure.
